Case Study – Bronze Craft Engineering Office

**Energy Savings, Ambient Conditions, & Outside
Influences of the Bronze Craft Engineering Office
Across Multiple Micro Climates**

Geoffrey Gomez

June 1, 2011

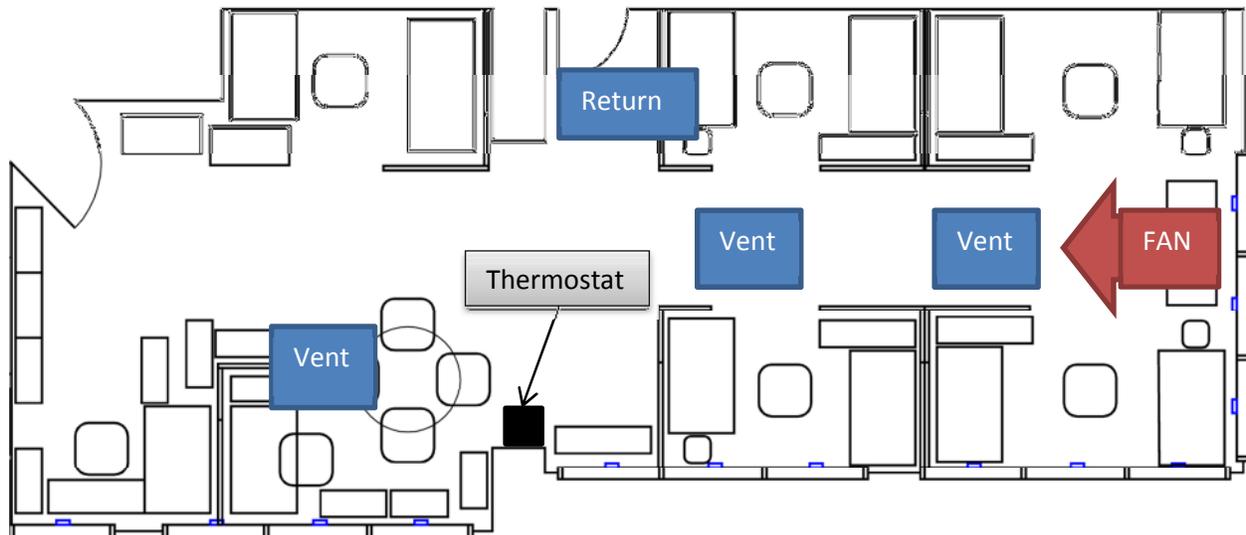
Figure 1 – Engineering Office Space Furniture Layout & HVAC Details

Note: Fan added after baseline data was gathered.

This temperature gradient problem was further exacerbated by the location of the HVAC ducts located in this area. The vents in this area, see Figure 1, direct their airflow in all directions. However, the resulting airflow from these ducts at sitting height was noticeable by the interior workspace occupants whom felt that the vents were blowing directly at their workspaces. And conversely, the occupants of the window area workspaces reported that the airflow of the ducts was not noticeable. Through these observations, it appears that the airflow across this section of the office was not evenly distributed.

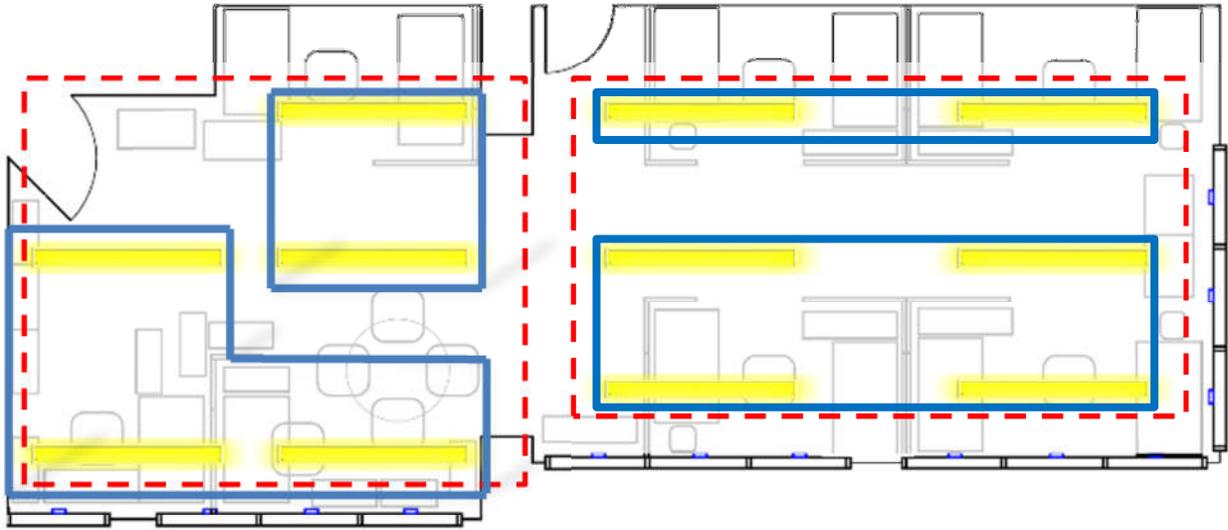
Figure 2 – Engineering Office Lighting Fixture Locations – Shown in Yellow
Lighting Zones: Pre-existing shown in Dashed Red Lines & Modified shown in Solid Blue Lines

In addition to the 16 SWS units, 2 power meters were added in line to the wiring for the overhead lighting units. Digi Smart Plugs were also placed to divide and control the lighting into 4 independently controlled sections, as noted in Figure 2. The 4 lighting zones were divided based upon their proximity to the windows. Workspaces located without any direct access to the windows were separated from the workspaces located next to the windows.

The wiring for the overhead lighting was modified to allow 4 Digi Smart Plugs to control the room in 4 distinct lighting zones, see Figure 2. The smart plugs allow remote and automated control of these 4 zones. The overhead lighting was divided to separate the lighting over the workspaces near the windows from the lighting of the workspaces at the interior of the office space.

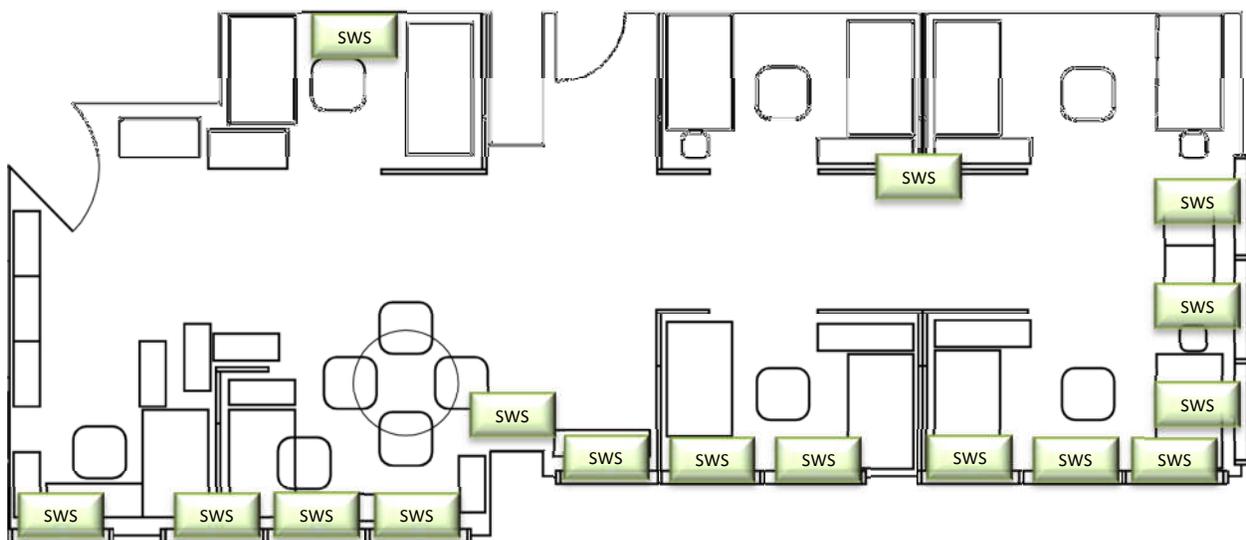
Figure 3 – Engineering Office Smart Window Sensors Locations

The office space was setup with 16 of the Smart Window Sensor units. Each of the 13 operable windows was retrofitted with a SWS unit and smart hardware for security integration. The units were mounted at the head of the hopper style windows at approximately 4 feet Above Finished Flooring (AFF). Two additional sensors were placed in the interior of the room at locations noted to be problematic by the room occupants. These interior SWS units were mounted at approximately 3 feet AFF to more accurately report conditions at the sitting height of the occupants. The existing programmable thermostat was replaced with a ZigBee enabled thermostat integrated with a SWS module. This thermostat SWS module was located at a height of approximately 5 feet AFF. The locations of all of these sensors are noted in Figure 3.

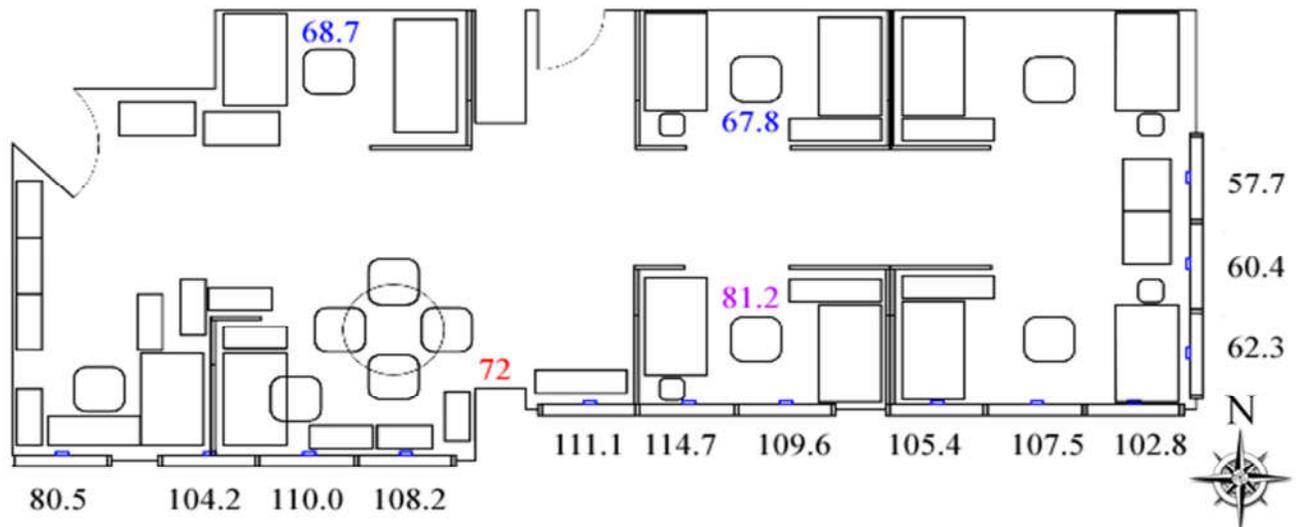
A sample of the measured temperature gradient is shown in Figure 4, with all temperatures given in degrees Fahrenheit. For this example, the weather was bright and sunny with a high temperature of 55 degrees. The data shown in Figure 4 is from a collection time of 11 AM.

Figure 4 – Example of Baseline Temperature Measurements Showing Temperature Gradient

The data shown in black numbers is the data from the SWS units mounted to the window frames and represent the thermal/solar gain at the windows. Analyzing just this window temperature

data demonstrates the direct effect of the sun on these windows. It is evident that the sun is brightly shining on the southern exposure as the temperature of these windows is well above 100 degrees. These windows were experiencing a large solar gain. It is important to further note that the lower left window shows a temperature below the other southerly windows. This lower temperature reading is most likely due to the fact that there is a large shrub that partially blocks this window on the exterior of the building.

The easterly facing windows, on the right side of Figure 4, show a very different temperature reading of over 50 degrees cooler than the other windows. The readings of these windows are only slightly above the external ambient temperature. These easterly windows were no longer in any direct sunlight and were in fact below the average internal temperature of the room. These windows were actually generating a thermal loss for the room.

In addition to the 13 window mounted SWS units, 4 other temperature readings were recorded at various locations across the interior of the room. These additional readings further demonstrated the temperature gradient in the office space. For example, in Figure 4, 3 readings were taken at varying distances from the window. Directly at the window, the temperature was measured by the SWS unit at around 110 degrees. Only 4 feet away from the window, the temperature was measured at 81.2 degrees by a supplemental handheld temperature sensor. In addition, at a total of 12 feet away from the window, the temperature was measured at 67.8 degrees. The temperature gradient caused by the windows is obvious here.

The programmable room thermostat was set to maintain a temperature between 70 and 74 degrees. In this example, Figure 4 shows, in red, that the thermostat was actually showing a temperature of 72 degrees, within the optimal temperature range of the program. However, the room occupants reported regularly having to manually override the thermostat settings due to the

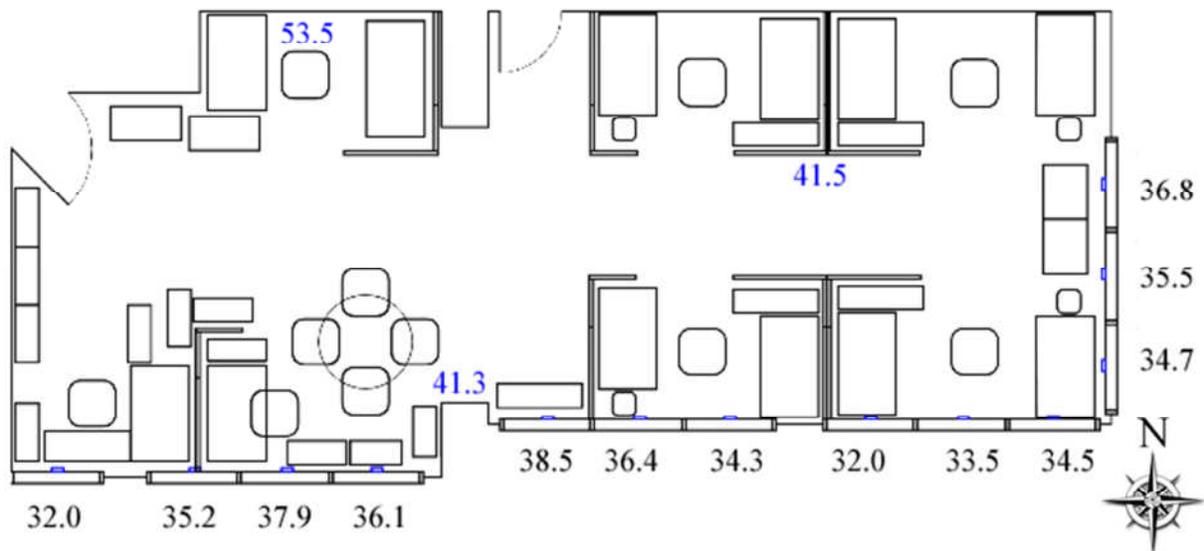
The sample data capture, shown in Figure 5, displays the SWS units' relative humidity levels captured at around 10 AM on a sunny day. The data shows that the levels across the windows range around 6% with a few areas that act as humidity pockets. The humidity levels across the interior of the office are much higher than the levels at the windows. Also, there are workspaces with much higher humidity pockets as compared to both the windows and the rest of the workspaces.

Figure 5 – Sample Humidity Distribution

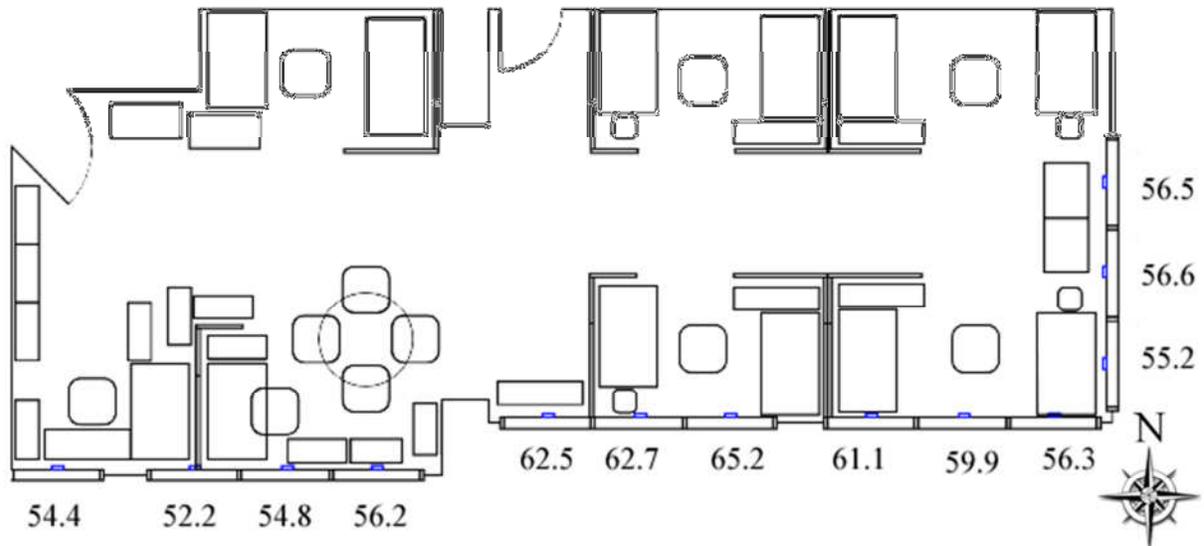
It is important to note that the humidity levels are definitely affected by the outside air. On several occasions, office occupants opened a window. The data shown in Figure 6 shows a sample data capture of the humidity levels with an open window. On this day, the weather was overcast and rainy.

The humidity distribution can be seen as a bell curve with the peak of humidity levels at the open window itself, labeled with the 65.2 % relative humidity level.

Figure 6 –Humidity Distribution – With an Open Window

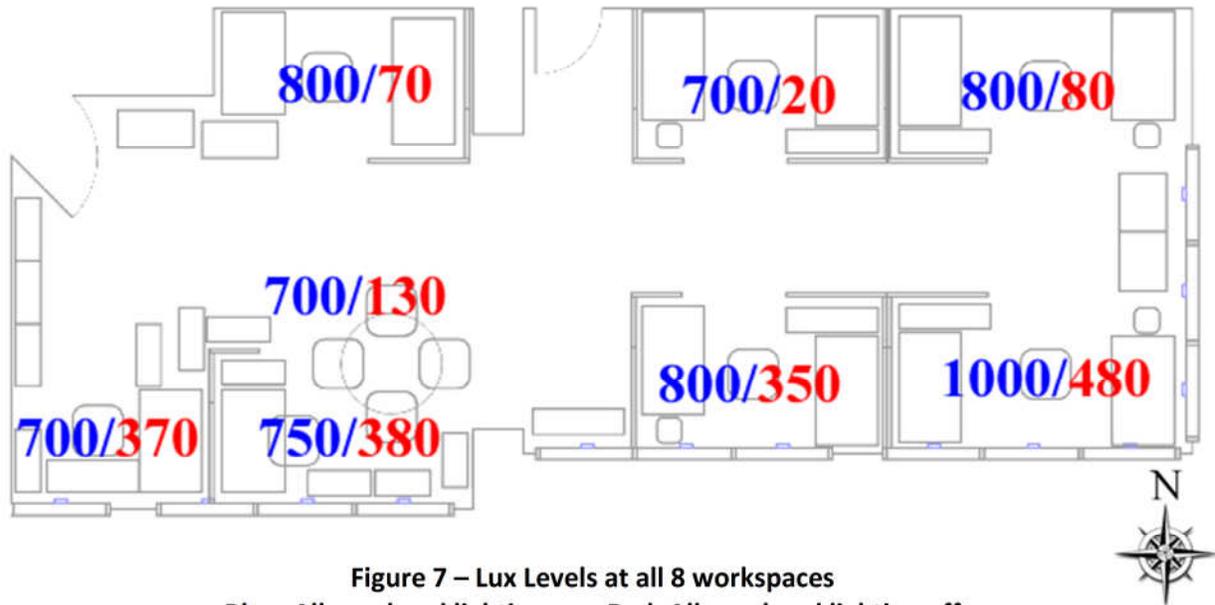
The governing standard for office workspace lighting levels is the Occupational Safety & Health Administration (OSHA) 1926.56(a) standard. In summary, the standard states that offices must have a minimum illumination intensity of 30 foot-candles which is equivalent to around 323 lux. The light level readings must also be taken at a height of 36" AFF. Utilizing this standard, measurements were taken, in lux, at each of the 8 workspaces in this office space, Figure 7. The lux measured at the windows, from the sun, averaged 5000 Lux during this data collection period.

Figure 7 – Lux Levels at all 8 workspaces
Blue: All overhead lighting on. Red: All overhead lighting off

Applying the OSHA 1929.56(a) lighting standard, it is evident that with the overhead lighting on, the light levels at each workspace greatly exceed the minimum lighting level of 323 lux. With all of the overhead lighting off, the impact of the exterior lighting is most evident. The light levels across the interior workspaces fall far below the minimum level for the standard. However, the workspaces immediately adjacent to the windows meet and exceed the minimum of the lighting standard.

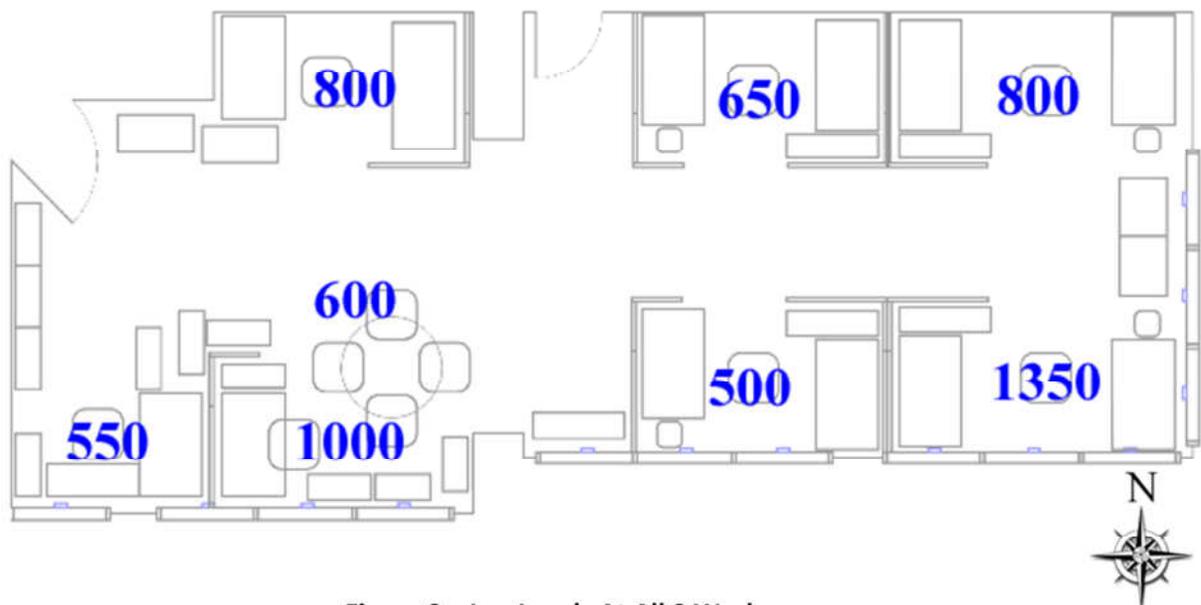
The software utilized the SWS lighting level data to control the lighting based upon a threshold of 5000 lux. The lux levels of each workspace were measured once above this threshold level. For this example, the lighting as measured at the windows was around 7500 lux. The window proximal lighting zones (see Figure 2) were turned off while the interior lighting zones were on. The lux levels at each of the workspaces were all measured well above the OSHA 323 lux lighting standards, see Figure 8.

**Figure 8 – Lux Levels At All 8 Workspaces
Interior Overhead Lighting On, Window Adjacent Lighting Off**

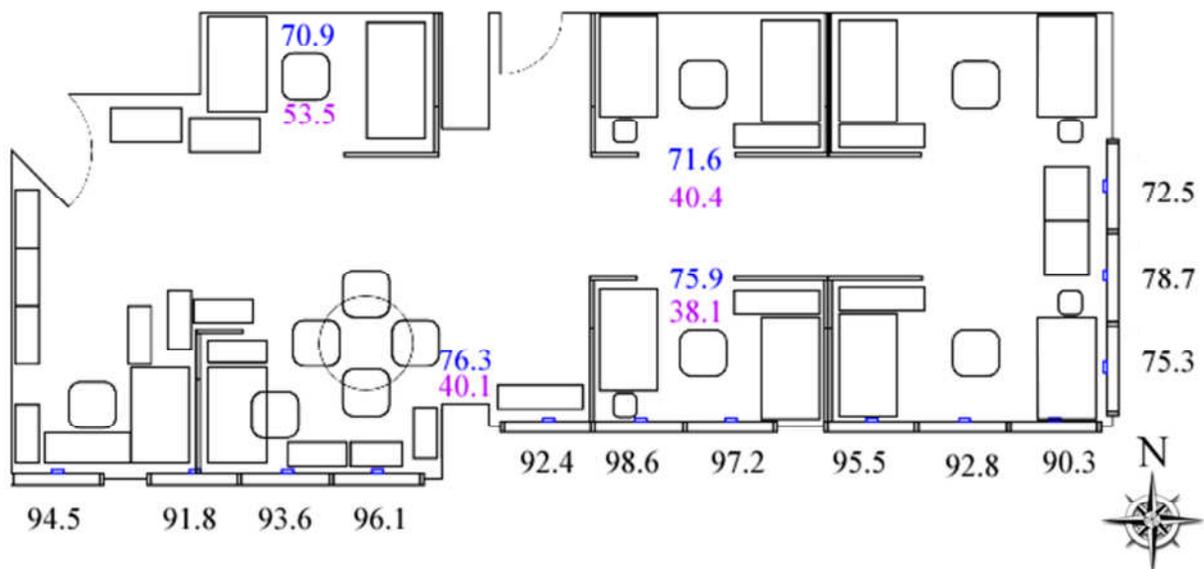
Utilizing the window mounted SWS unit's temperature readings did reduce the occupant perceived effect of the window thermal gain. The temperature distribution of the office space was better balanced across the office space and the occupants did report an improvement in their comfort levels. However, the gradient across the office was not eliminated. The temperature distribution across the office dropped from 12.5 degrees (Figure 4) to 5.4 degrees (Figure 9). The change in the perceived temperature gradient seems to be directly related to the air circulator's role in moving the air around the room. Though not quantified directly, the HVAC system appeared, through observation, to run for shorter periods and stay off for longer periods. Further evaluation of the HVAC runtime is recommended (see the Recommendations section for further analysis) as no true conclusion can be made on possible energy savings at this time.

Figure 9 – Temperature and Humidity Distribution Across the Office Space
Black: Window Temperature. Blue: Interior Temperature. Purple: Interior Humidity
