The Bronze Craft Corporation

Case Study – Bronze Craft Engineering Office

Energy Savings, Ambient Conditions, & Outside
Influences of the Bronze Craft Engineering Office
Across Multiple Micro Climates

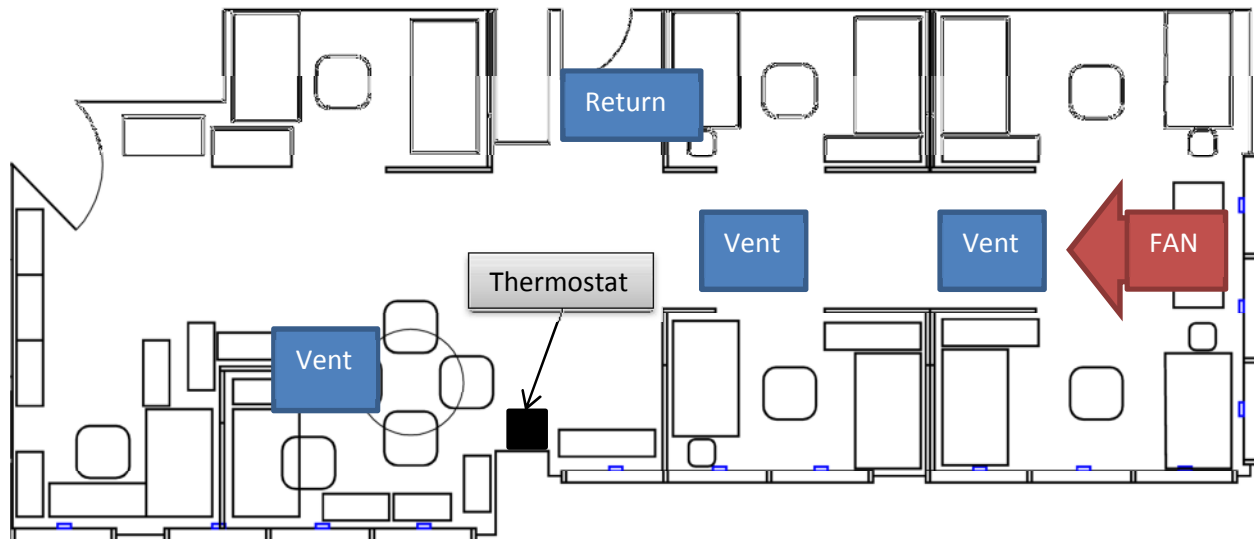
- Office Space Setup
 - Fully enclosed office space
 - Office area footprint of 712 ft²
 - 7 cubicles and 1 meeting space
 - Office Air Volume of 6764 ft³
 - 5 window banks with 13 operable windows (locations noted in Figure 1)
 - 10 windows facing south
 - 3 windows facing east
 - Window surface area of 163 ft²
 - 1 HVAC system for the office space (details noted in Figure 1)
 - 3 Duct vents
 - 1 Air return
 - 1 programmable thermostat controller
 - 2 lighting zones/switches to control room lighting (locations noted in Figure 2)
 - 12 florescent light banks – each bank with 4 bulbs

Figure 1 – Engineering Office Space Furniture Layout & HVAC Details

Note: Fan added after baseline data was gathered.

This temperature gradient problem was further exacerbated by the location of the HVAC ducts located in this area. The vents in this area, see Figure 1, direct their airflow in all directions. However, the resulting airflow from these ducts at sitting height was noticeable by the interior workspace occupants whom felt that the vents were blowing directly at their workspaces. And conversely, the occupants of the window area workspaces reported that the airflow of the ducts was not noticeable. Through these observations, it appears that the airflow across this section of the office was not evenly distributed.

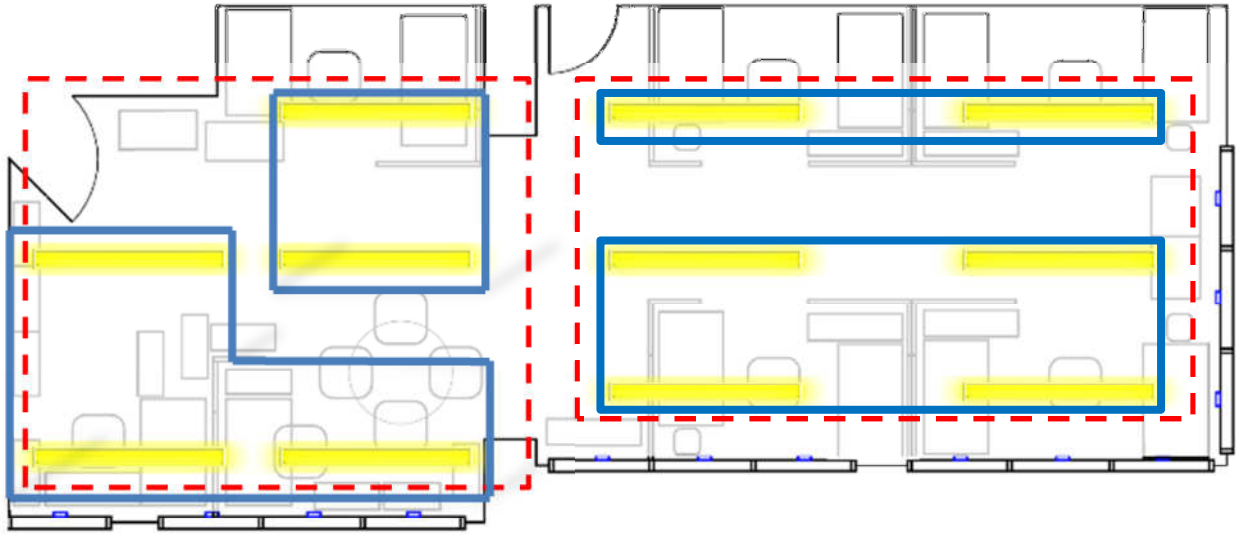
Figure 2 – Engineering Office Lighting Fixture Locations – Shown in Yellow
Lighting Zones: Pre-existing shown in Dashed Red Lines & Modified shown in Solid Blue Lines

In addition to the 16 SWS units, 2 power meters were added in line to the wiring for the overhead lighting units. Digi Smart Plugs were also placed to divide and control the lighting into 4 independently controlled sections, as noted in Figure 2. The 4 lighting zones were divided based upon their proximity to the windows. Workspaces located without any direct access to the windows were separated from the workspaces located next to the windows.

The wiring for the overhead lighting was modified to allow 4 Digi Smart Plugs to control the room in 4 distinct lighting zones, see Figure 2. The smart plugs allow remote and automated control of these 4 zones. The overhead lighting was divided to separate the lighting over the workspaces near the windows from the lighting of the workspaces at the interior of the office space.

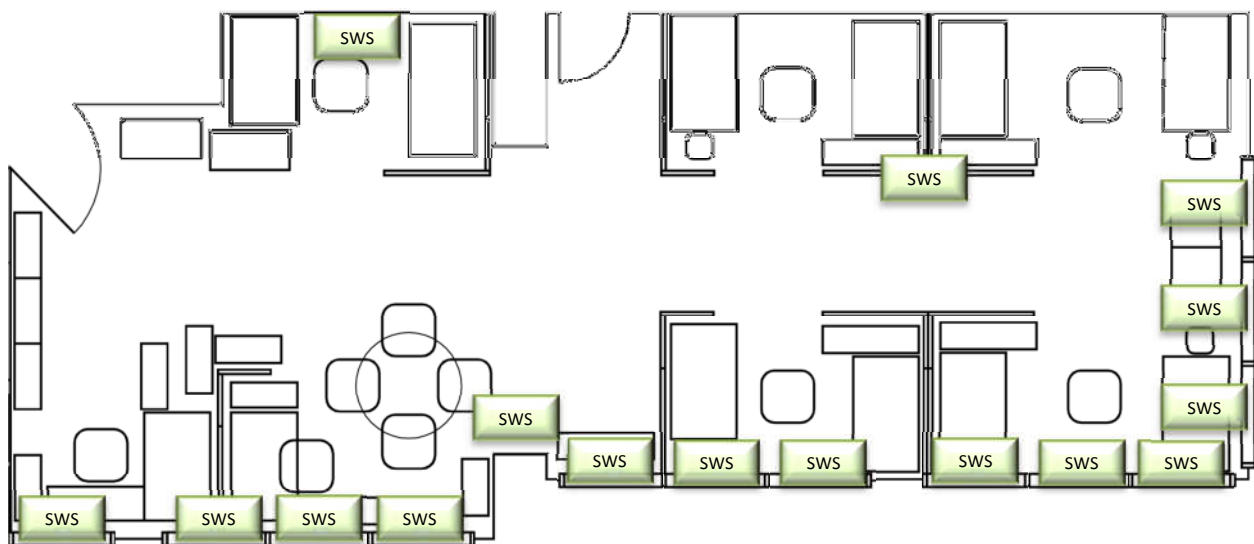
The office space was setup with 16 of the Smart Window Sensor units. Each of the 13 operable windows was retrofitted with a SWS unit and smart hardware for security integration. The units were mounted at the head of the hopper style windows at approximately 4 feet Above Finished Flooring (AFF). Two additional sensors were placed in the interior of the room at locations noted to be problematic by the room occupants. These interior SWS units were mounted at approximately 3 feet AFF to more accurately report conditions at the sitting height of the occupants. The existing programmable thermostat was replaced with a ZigBee enabled thermostat integrated with a SWS module. This thermostat SWS module was located at a height of approximately 5 feet AFF. The locations of all of these sensors are noted in Figure 3.

Figure 3 – Engineering Office Smart Window Sensors Locations

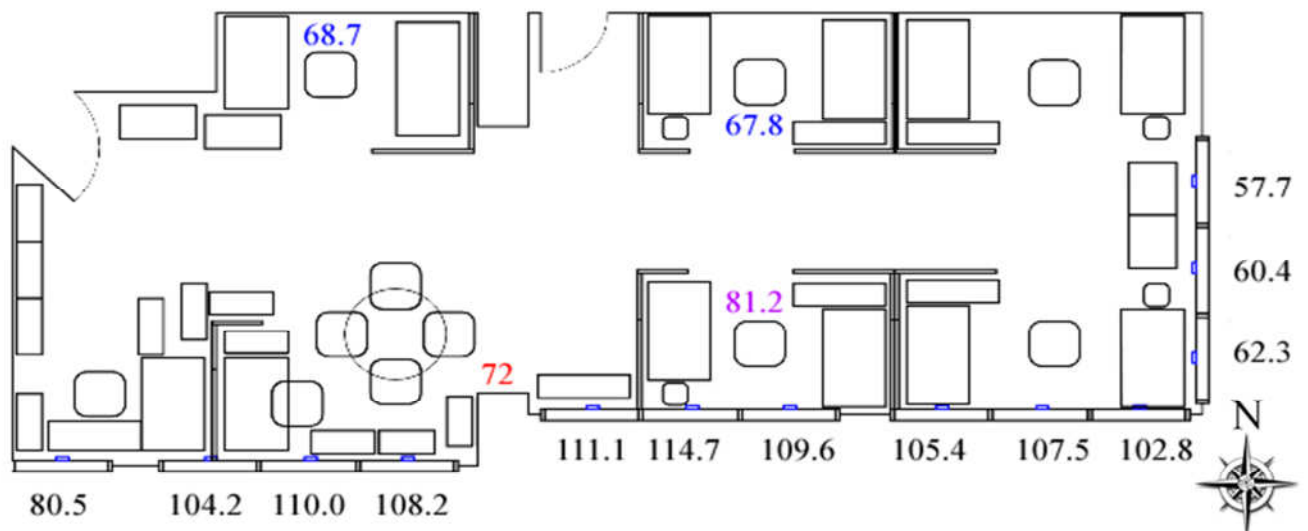
A sample of the measured temperature gradient is shown in Figure 4, with all temperatures given in degrees Fahrenheit. For this example, the weather was bright and sunny with a high temperature of 55 degrees. The data shown in Figure 4 is from a collection time of 11 AM.

Figure 4 – Example of Baseline Temperature Measurements Showing Temperature Gradient

The data shown in black numbers is the data from the SWS units mounted to the window frames and represent the thermal/solar gain at the windows. Analyzing just this window temperature

data demonstrates the direct effect of the sun on these windows. It is evident that the sun is brightly shining on the southern exposure as the temperature of these windows is well above 100 degrees. These windows were experiencing a large solar gain. It is important to further note that the lower left window shows a temperature below the other southerly windows. This lower temperature reading is most likely due to the fact that there is a large shrub that partially blocks this window on the exterior of the building.

The easterly facing windows, on the right side of Figure 4, show a very different temperature reading of over 50 degrees cooler than the other windows. The readings of these windows are only slightly above the external ambient temperature. These easterly windows were no longer in any direct sunlight and were in fact below the average internal temperature of the room. These windows were actually generating a thermal loss for the room.

In addition to the 13 window mounted SWS units, 4 other temperature readings were recorded at various locations across the interior of the room. These additional readings further demonstrated the temperature gradient in the office space. For example, in Figure 4, 3 readings were taken at varying distances from the window. Directly at the window, the temperature was measured by the SWS unit at around 110 degrees. Only 4 feet away from the window, the temperature was measured at 81.2 degrees by a supplemental handheld temperature sensor. In addition, at a total of 12 feet away from the window, the temperature was measured at 67.8 degrees. The temperature gradient caused by the windows is obvious here.

The programmable room thermostat was set to maintain a temperature between 70 and 74 degrees. In this example, Figure 4 shows, in red, that the thermostat was actually showing a temperature of 72 degrees, within the optimal temperature range of the program. However, the room occupants reported regularly having to manually override the thermostat settings due to the

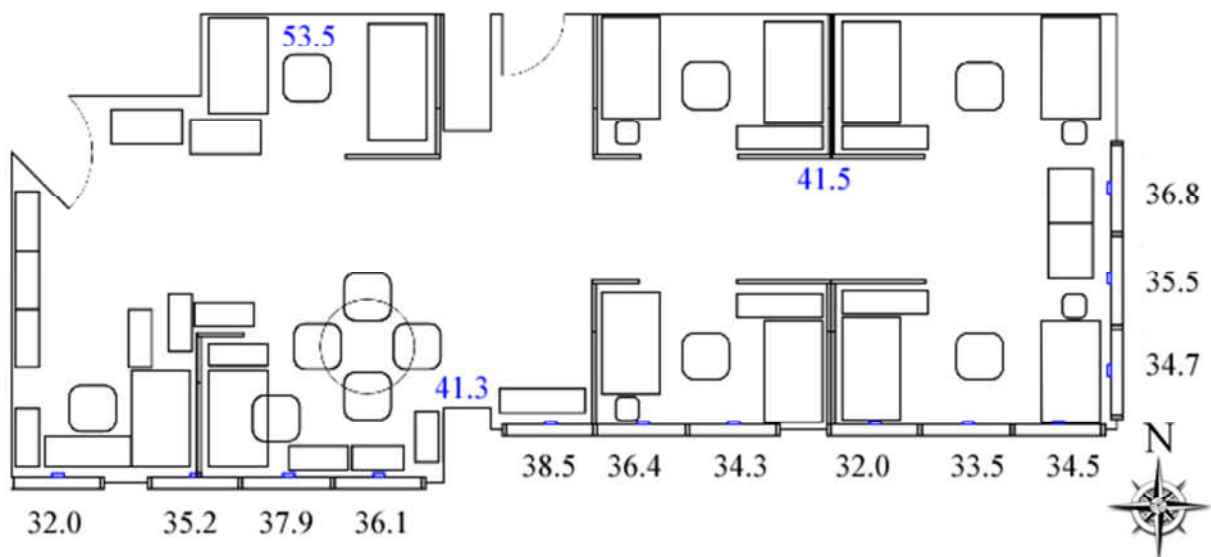
The sample data capture, shown in Figure 5, displays the SWS units' relative humidity levels captured at around 10 AM on a sunny day. The data shows that the levels across the windows range around 6% with a few areas that act as humidity pockets. The humidity levels across the interior of the office are much higher than the levels at the windows. Also, there are workspaces with much higher humidity pockets as compared to both the windows and the rest of the workspaces.

Figure 5 – Sample Humidity Distribution

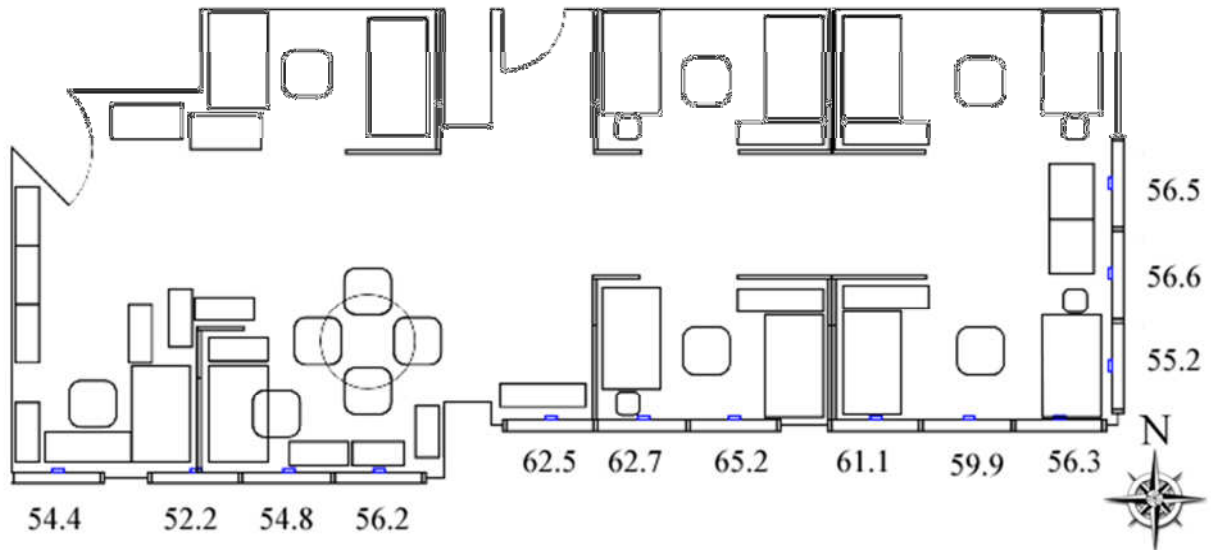
It is important to note that the humidity levels are definitely affected by the outside air. On several occasions, office occupants opened a window. The data shown in Figure 6 shows a sample data capture of the humidity levels with an open window. On this day, the weather was overcast and rainy.

The humidity distribution can be seen as a bell curve with the peak of humidity levels at the open window itself, labeled with the 65.2 % relative humidity level.

Figure 6 –Humidity Distribution – With an Open Window

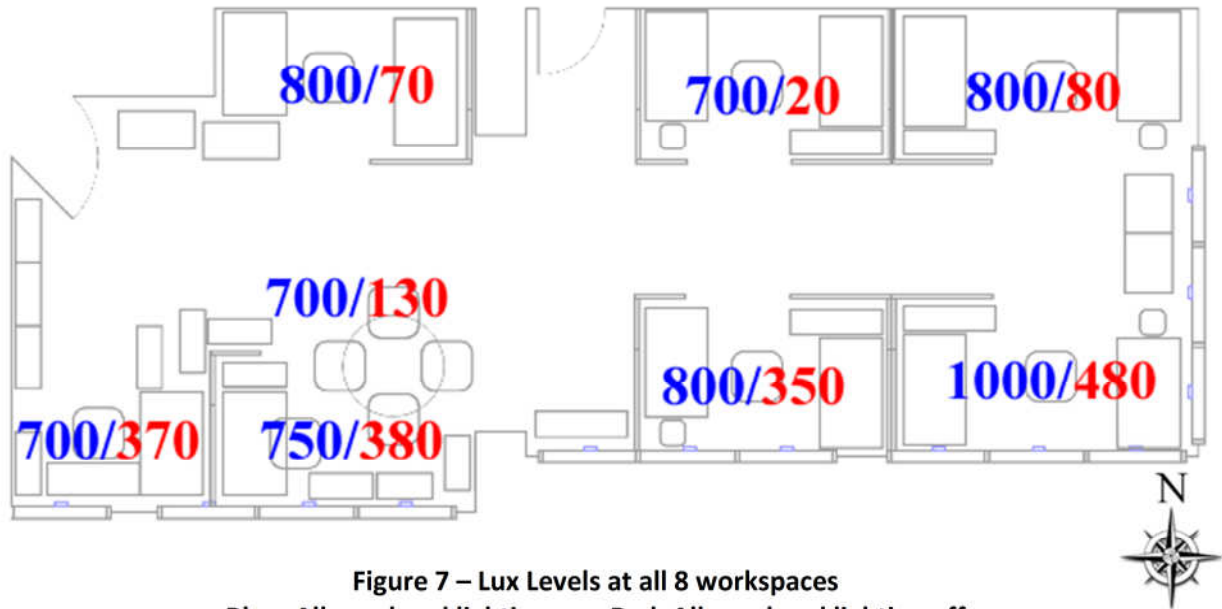
The governing standard for office workspace lighting levels is the Occupational Safety & Health Administration (OSHA) 1926.56(a) standard. In summary, the standard states that offices must have a minimum illumination intensity of 30 foot-candles which is equivalent to around 323 lux. The light level readings must also be taken at a height of 36" AFF. Utilizing this standard, measurements were taken, in lux, at each of the 8 workspaces in this office space, Figure 7. The lux measured at the windows, from the sun, averaged 5000 Lux during this data collection period.

Figure 7 – Lux Levels at all 8 workspaces
Blue: All overhead lighting on. Red: All overhead lighting off

Applying the OSHA 1929.56(a) lighting standard, it is evident that with the overhead lighting on, the light levels at each workspace greatly exceed the minimum lighting level of 323 lux. With all of the overhead lighting off, the impact of the exterior lighting is most evident. The light levels across the interior workspaces fall far below the minimum level for the standard. However, the workspaces immediately adjacent to the windows meet and exceed the minimum of the lighting standard.

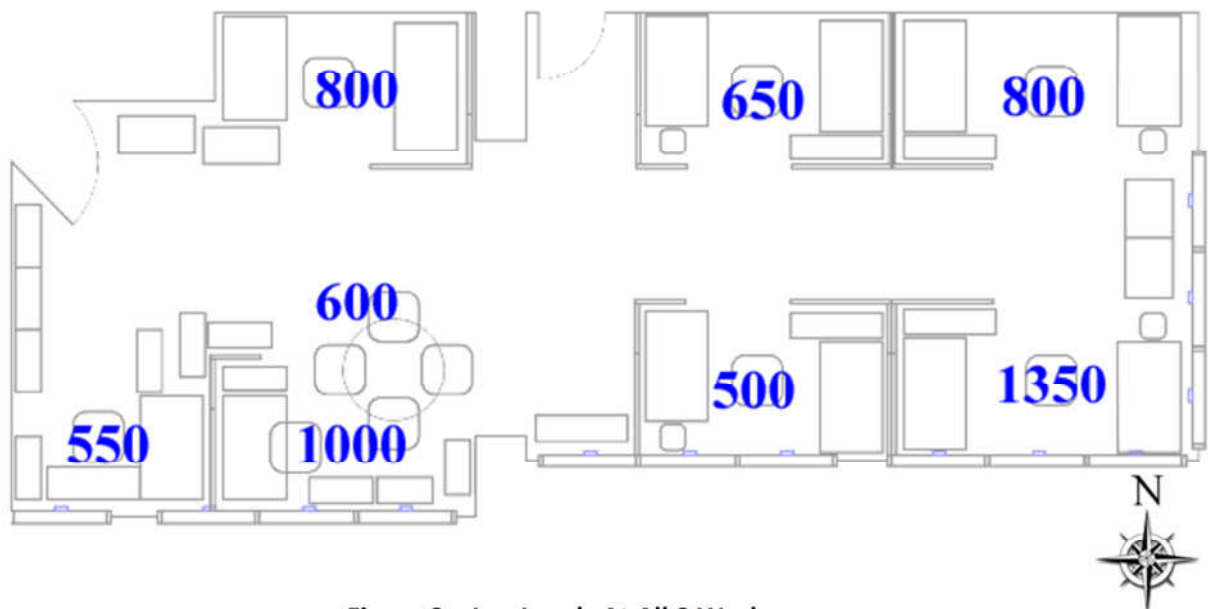
The software utilized the SWS lighting level data to control the lighting based upon a threshold of 5000 lux. The lux levels of each workspace were measured once above this threshold level. For this example, the lighting as measured at the windows was around 7500 lux. The window proximal lighting zones (see Figure 2) were turned off while the interior lighting zones were on. The lux levels at each of the workspaces were all measured well above the OSHA 323 lux lighting standards, see Figure 8.

**Figure 8 – Lux Levels At All 8 Workspaces
Interior Overhead Lighting On, Window Adjacent Lighting Off**

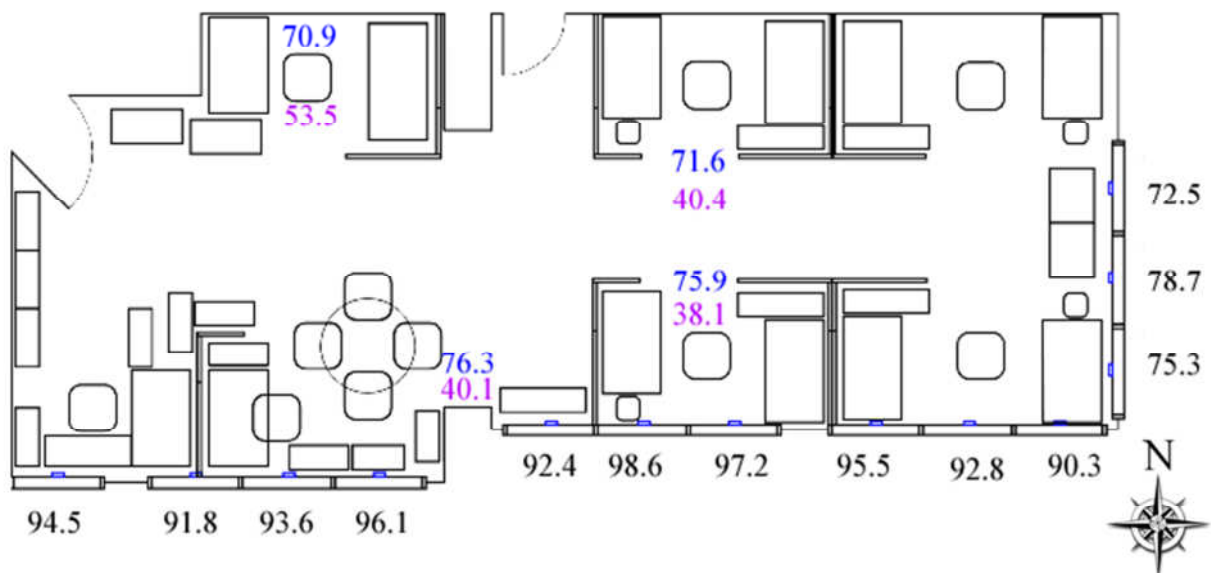
Utilizing the window mounted SWS unit's temperature readings did reduce the occupant perceived effect of the window thermal gain. The temperature distribution of the office space was better balanced across the office space and the occupants did report an improvement in their comfort levels. However, the gradient across the office was not eliminated. The temperature distribution across the office dropped from 12.5 degrees (Figure 4) to 5.4 degrees (Figure 9). The change in the perceived temperature gradient seems to be directly related to the air circulator's role in moving the air around the room. Though not quantified directly, the HVAC system appeared, through observation, to run for shorter periods and stay off for longer periods. Further evaluation of the HVAC runtime is recommended (see the Recommendations section for further analysis) as no true conclusion can be made on possible energy savings at this time.

Figure 9 – Temperature and Humidity Distribution Across the Office Space
Black: Window Temperature. Blue: Interior Temperature. Purple: Interior Humidity
